Influence of Safety Valve Pressure on Gelled Electrolyte Valve-Regulated Lead/Acid Batteries Under Deep Cycling Applications

Cycle life tests have been carried out to evaluate the influence of safety valve pressure on valve regulated lead/acid batteries under deep cycling applications. Batteries were cycled at 5 hour rates at 100% DOD, and safety valve pressure was set to 1.08 and 2.00 bar, respectively. The batteries lost 248.3 g and 235.3 g of water for each case after about 1,200 cycles, but the cyclic performances of the batteries were comparable. Most of the gas of the battery during discharging was hydrogen, and the oxygen concentration increased to 18% after 3 hours of charging. The micro structure of the positive active materials was completely changed and the corrosion layer of the positive grid was less than 50 μm , regardless of the pressure of the safety valve after cycle life tests. The cause of discharge capacity decrease was found to be water loss and the shedding of the positive active materials. The pressure of safety valve does not give little effect to the cyclic performances and the failure modes of the gelled electrolyte valve-regulated lead acid batteries.

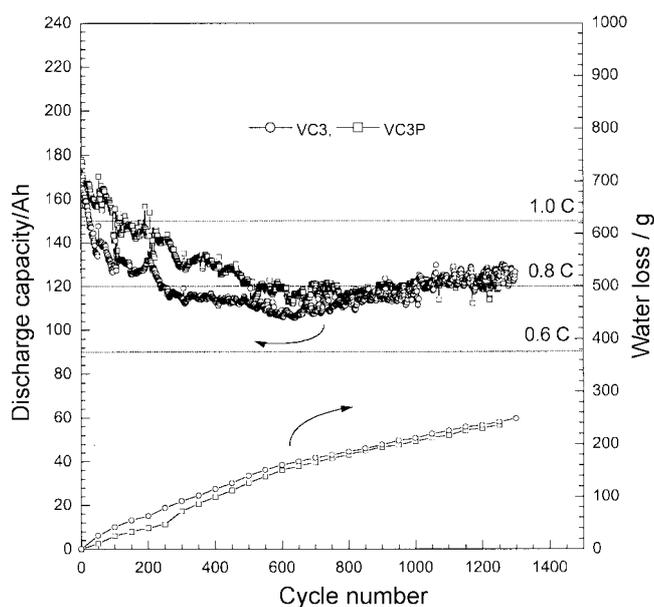
Figure 1. Changes of discharge capacity and water loss on the pressure of safety valve during cycle life test.

Figure 1 shows the changes in discharge capacity and water loss of the VRLA batteries during cycle life tests. As the tests progressed, the discharge capacity of the VC3 battery decreased more rapidly to below 0.8 C than the discharging capacity of the VC3P battery. Interestingly, the battery that led in discharge capacity decrease lost more water. This indicates that the decrease in discharge capacity was relative to the amount of water loss. VC3 and VC3P batteries had lost 248.3 g and 235.3 g of water after 1,200 cycles, respectively, but the cyclic performances of both batteries were comparable.

A second noteworthy feature concerned the recovery of discharge capacity after 600 cycles to above 0.8 C in both batteries. This resulted from the structural change in the positive active materials during repetitive charge-discharge

indicate the increase in the oxygen recombination reaction rate at the negative plate.¹⁰⁻¹⁶ During cycling, the pressure dip at an early stage of charging was deeper and broader, and the amount of water loss per one cycle decreased, as shown in Figure 1. In the VC3 battery, the safety valve was opened about 1.06 bar, and internal pressure was decreased to about

Because the reaction rate of hydrogen recombination on the positive plate is very slow^{10,17} and the evolving rate is faster than recombination, the amount of hydrogen increases with cycling. An increasing oxygen recombination rate and decreasing water loss rate were expected with higher safety valve pressure. However, the VC3P battery reveals only an 8% effect on water loss, as shown in Figure 1.

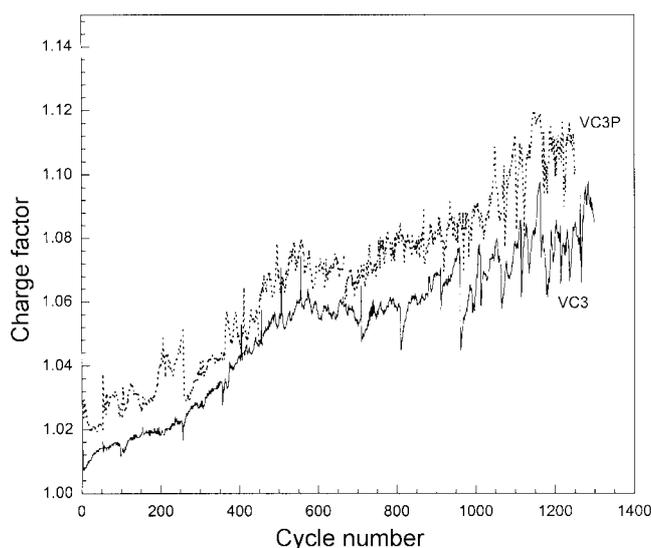
Figure 2. Changes of charge factor on the pressure of safety valve during cycle life test.

Figure 2 shows the charge factor of the batteries during cycle life tests. The charge factor, the value of the discharged capacity over charged capacity, was bigger than one because the charging efficiency of the positive plate was in the range of 70-90%. The difference in the charge factors at the starting point was about 1%. This was probably caused by the difference in the internal resistance stemming from the manufacturing process. Generally, the charge factor in lead acid batteries is in the range of 1.07 to 1.20, but it varies with internal structure, type of electrolyte and applications. The overcharged electricity play a role in the corrosion of the positive grid and electrolysis of water as follow.

During cycle tests limited by the charging voltage, as in the present study, heat generation and the charge factor increased continuously because the internal resistance of the battery increased with the change of micro structure. The VC3P battery with more discharge capacity showed a higher charge factor in cycle life tests. This might suggest that the test battery with the higher charge factor loses water more. But VC3P lost less water than VC3, as shown in Figure 1. The reason is that the oxygen recombination reaction on the negative plate of the VC3P battery was accelerated with higher oxygen pressure because of the higher setting of the safety valve pressure.

An interesting note is that the slope of the charge factor changed around 600 cycles, same as the cycle number for water loss in Figure 1. This means that the charge factor and water loss are related very closely with the micro structure of the positive plate. The fluctuations of the charge factor increased gradually during cycle life tests in both batteries. This suggests that the structure of the positive plate

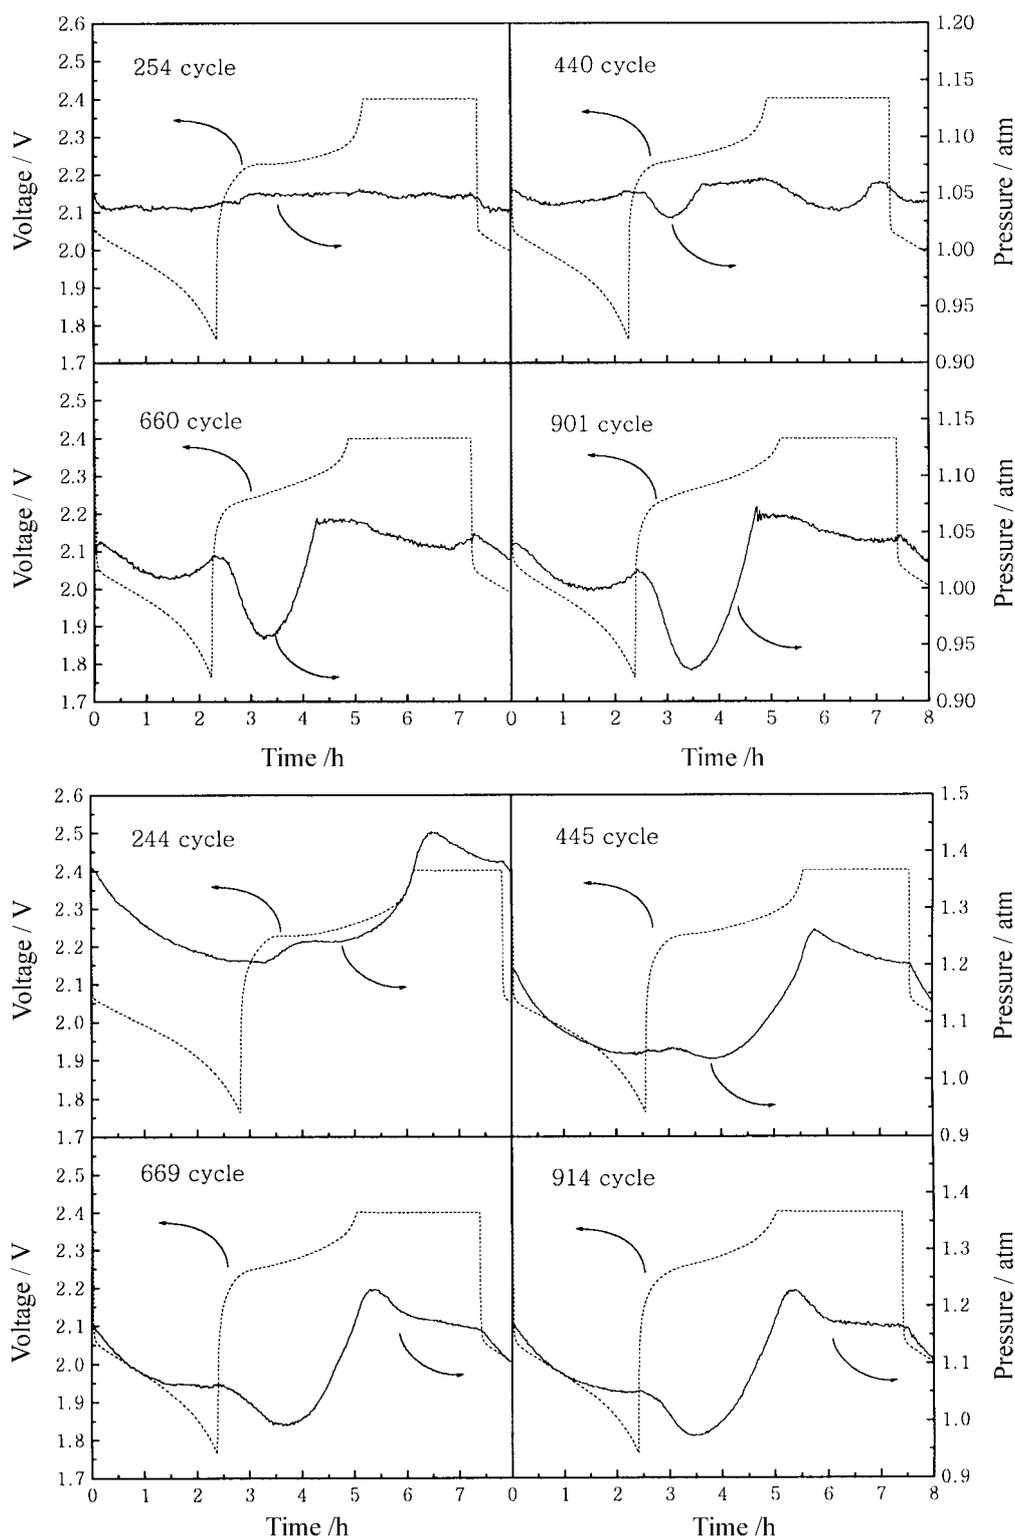
Figure 3. Changes of internal pressure during cycle life test of (a) VC3 and (b) VC3P batteries.

Figure 3 shows the changes in internal pressure and battery voltage during cycle test. The internal pressure of the VC3 battery was not changed during charging and discharging at 254 cycles. Pressure dips appeared at an early and later stage of charging at 440 cycles. These pressure dips

0.93 bar during charging at 901 cycles. Pressure fluctuations in the plateau after the pressure dip were caused by opening the safety valve.

Significantly different results were obtained with the VC3P battery as seen in Figure 3(b). In spite of the safety valve being set to 2.0 bar, the peak pressure was about 1.45 bar, and peak pressure decreased to 1.23 bar at 244 cycles. Peak pressure decreased during cycling, and the pressure dip appeared during charging at 669 cycles. The typical shape of the internal pressure was changed by the oxygen recombination reaction when the VRLA battery was charged at constant voltage¹⁵⁻¹⁷ after 669 cycles. From this results, it can be inferred that the VC3P battery was more efficient at oxygen recombination reactions than the VC3 battery and that the increase in the pressure of the safety valve could reduce the water loss of the VRLA battery by improving the oxygen recombination reaction, as shown in Figure 1.

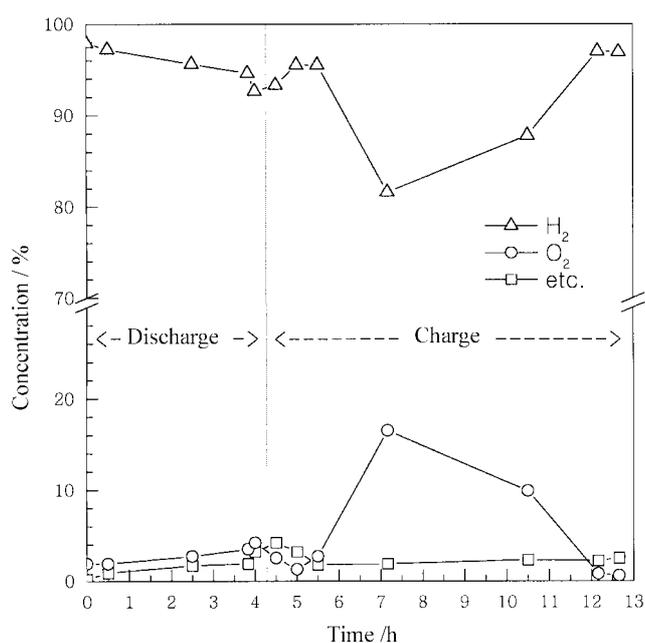
Figure 4. Changes of gas composition at 700th cycle of VC3 battery.

To confirm the dipping effect on pressure, as shown in Figure 3, the composition of gases produced in the VC3 battery was analyzed by a precision gas mass spectrometer. After 700 cycles, 12 samples were taken periodically during discharging and charging by a gas tight syringe and analyzed. Figure 4 shows the results for gas analysis. When a battery was discharging, most of the gas was hydrogen. But during the charging, oxygen content increased initially and finally decreased because of the oxygen recombination process.¹⁰ The identical effect occurred with the VC3P battery. Evolved oxygen recombined on the negative plate to water, therefore the oxygen content was reduced.¹⁵

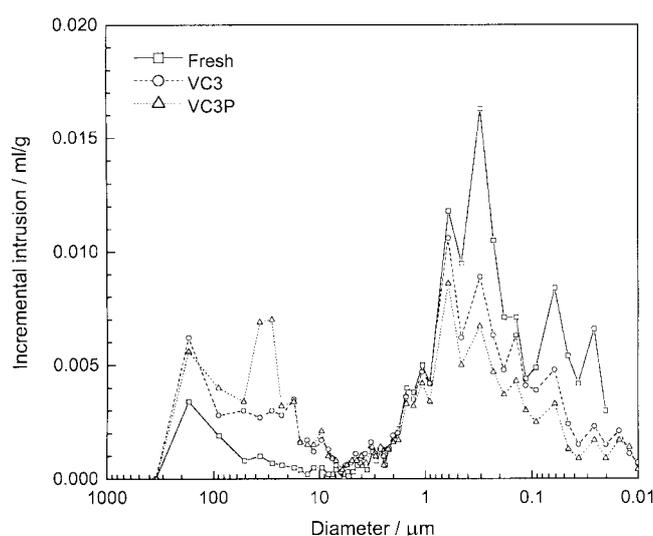
Figure 5. Pore size distributions of the positive plate of a fresh and tested batteries.

Figure 5 shows a comparison of pore size distribution of the positive active materials of fresh and cycled batteries. This shows that there are two types of pores. The large pores are larger than 100 μm and the small pores are less than 1

μm . With cycling, the proportion of small pores decreased, and the proportion of large pores increased with violent gassing on charging. But safety valve pressure had little effect on the structure of positive active materials.

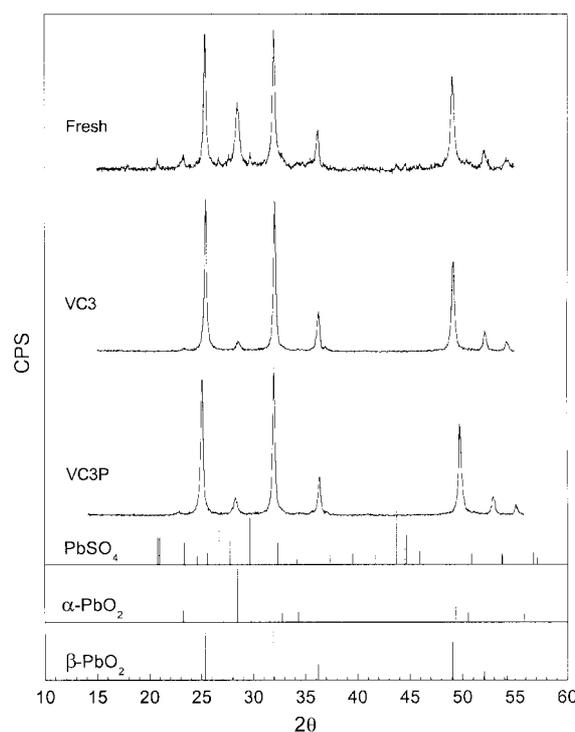
Figure 6. Comparison of XRD patterns of the positive active materials for a fresh and tested batteries.

A comparison of the XRD patterns of the positive active materials in the charged state is given in Figure 6. The α -

PbO_2 , residing on the inside of the plate decreased with cycling,^{19,20} and PbSO_4 was not observed after cycle life tests. There was no change in XRD patterns of the battery's positive active materials with change in safety valve pressure. We concluded, the mechanical structure and chemical composition of the plate do not change with higher safety valve pressure.

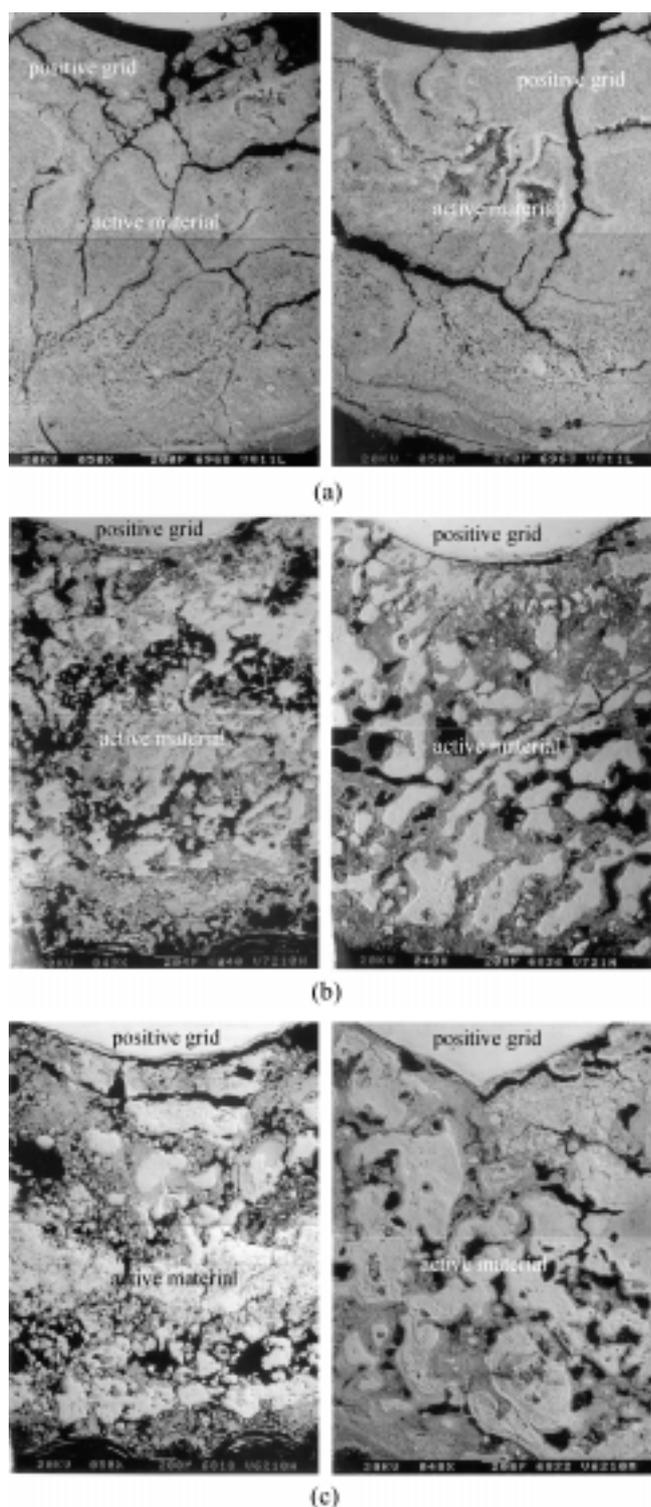
Figure 7. SEM photographs of a cross section of the positive plate. (a) fresh, (b) VC3, and (c) VC3P batteries.

To observe changes in the micro structure of the positive active materials, fresh, VC3 and VC3P batteries were disassembled and examined by SEM. VC3 and VC3P batteries, 1,300 cycled and 1,250 cycled, respectively, were used. The comparison of the micro structures of fresh and cycled batteries is shown in Figure 7. Active materials (gray color in the SEM photographs) consist of micro porous structures and there were many cracks (black color) formed during production. The active material was partly separated with a grid (Figure 7(a)).

The left and right SEM photographs in Figure 7(b) and (c) show the upper and middle part of the positive active materials of the tested batteries, respectively. Separated interfaces and cracks disappeared because of the swelling of the active materials,^{21,22} and there was severe deterioration in the active materials, which appeared as a colloidal structure.^{5,23,24} Pores larger than $100 \mu\text{m}$ and agglomerated active material (white color in SEM photograph) are shown in Figure 7(b) and (c). The many big pores and agglomerations on the plate is related to the rearranging of the active materials by evolved oxygen during charging. Since there was a difference in electrical conductivity with grid height under deep cycling application, the upper part of the positive plate deteriorated more rapidly than the middle and bottom parts.

In spite of the deep cycling application, positive grids were corroded slightly, and the corrosion layer was about $50 \mu\text{m}$ thick and distinguishable from the active materials. Therefore, porous active materials were shedded by violent gassing under high current charging.^{4,5,10} But, there was no significant difference in the mode of deterioration of the positive active materials from safety valve pressure.
